**GEOTECHNICAL EVALUATION
LEVEE EVALUATION AND CERTIFICATION
4403 SOUTH DISHMAN-MICA ROAD
SPOKANE COUNTY, WASHINGTON**

Inland Pacific Engineering Company Project No. 14-037

**February 12, 2015
Revised August 29, 2016**

Re: **Geotechnical Evaluation**
Chester Creek Levee Certification
4403 South Dishman-Mica Road
Spokane County, WA

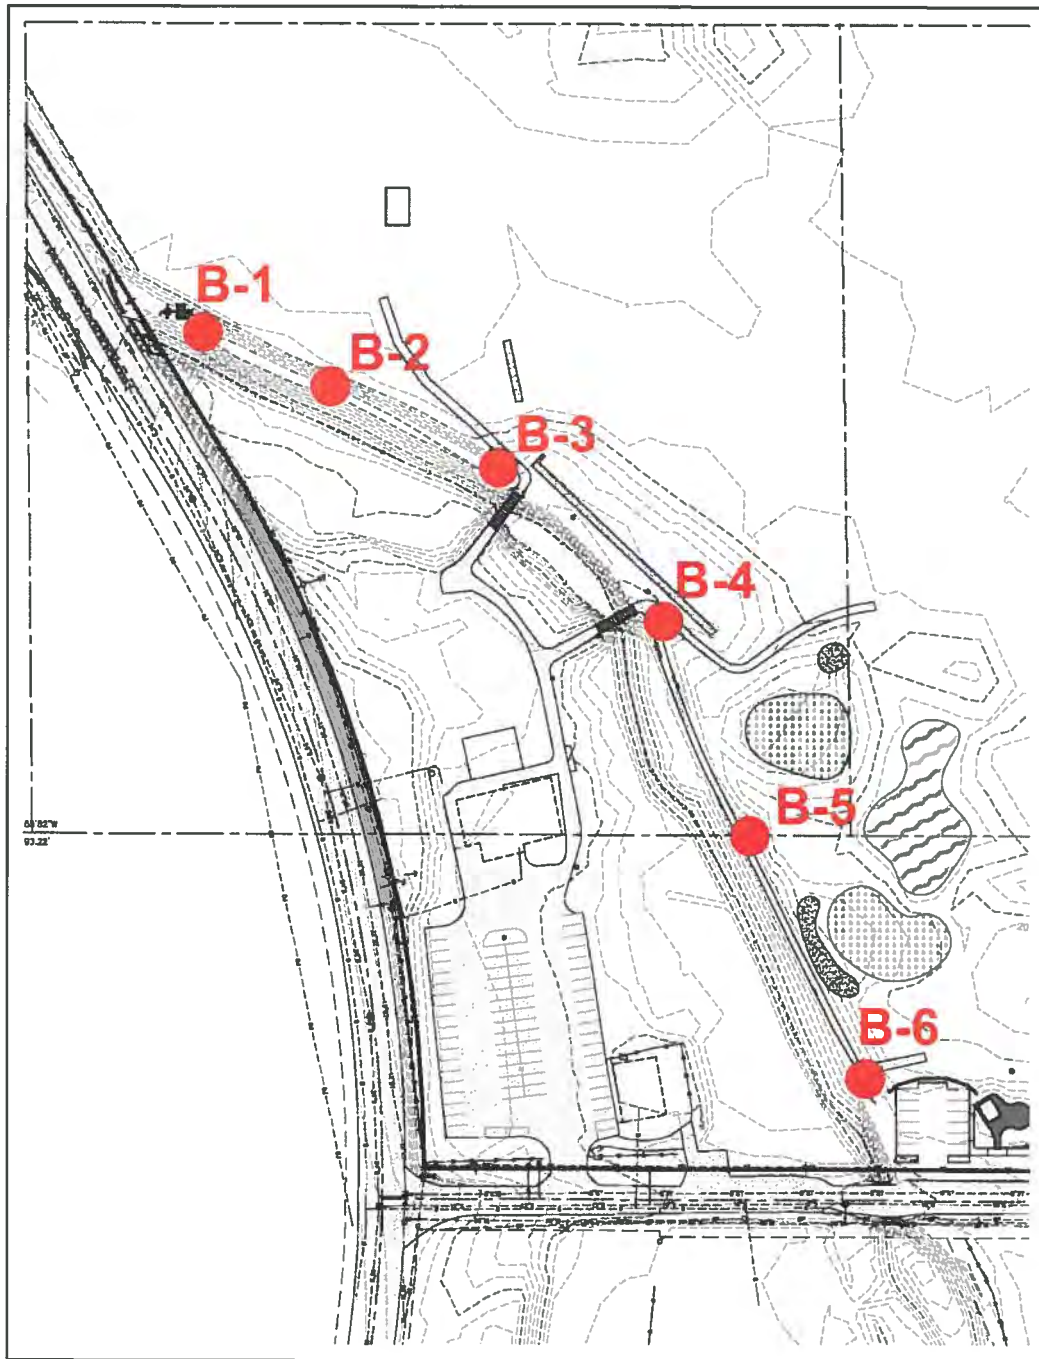
FIGURE 3

The borings were drilled at or near locations selected by us. The boring locations are shown on the Boring Location Map in Appendix A. The borings were staked by Whipple Consulting Engineers, Inc. (WCE). Ground surface elevations at the borings were provided by WCE.
