**PRELIMINARY GEOTECHNICAL EVALUATION  
PHASE I  
PAINTED HILLS GOLF COURSE PROPERTY  
4403 SOUTH DISHMAN-MICA ROAD  
SPOKANE COUNTY, WASHINGTON**

**Inland Pacific Engineering Company Project No. 2013-026**

**December 31, 2013**

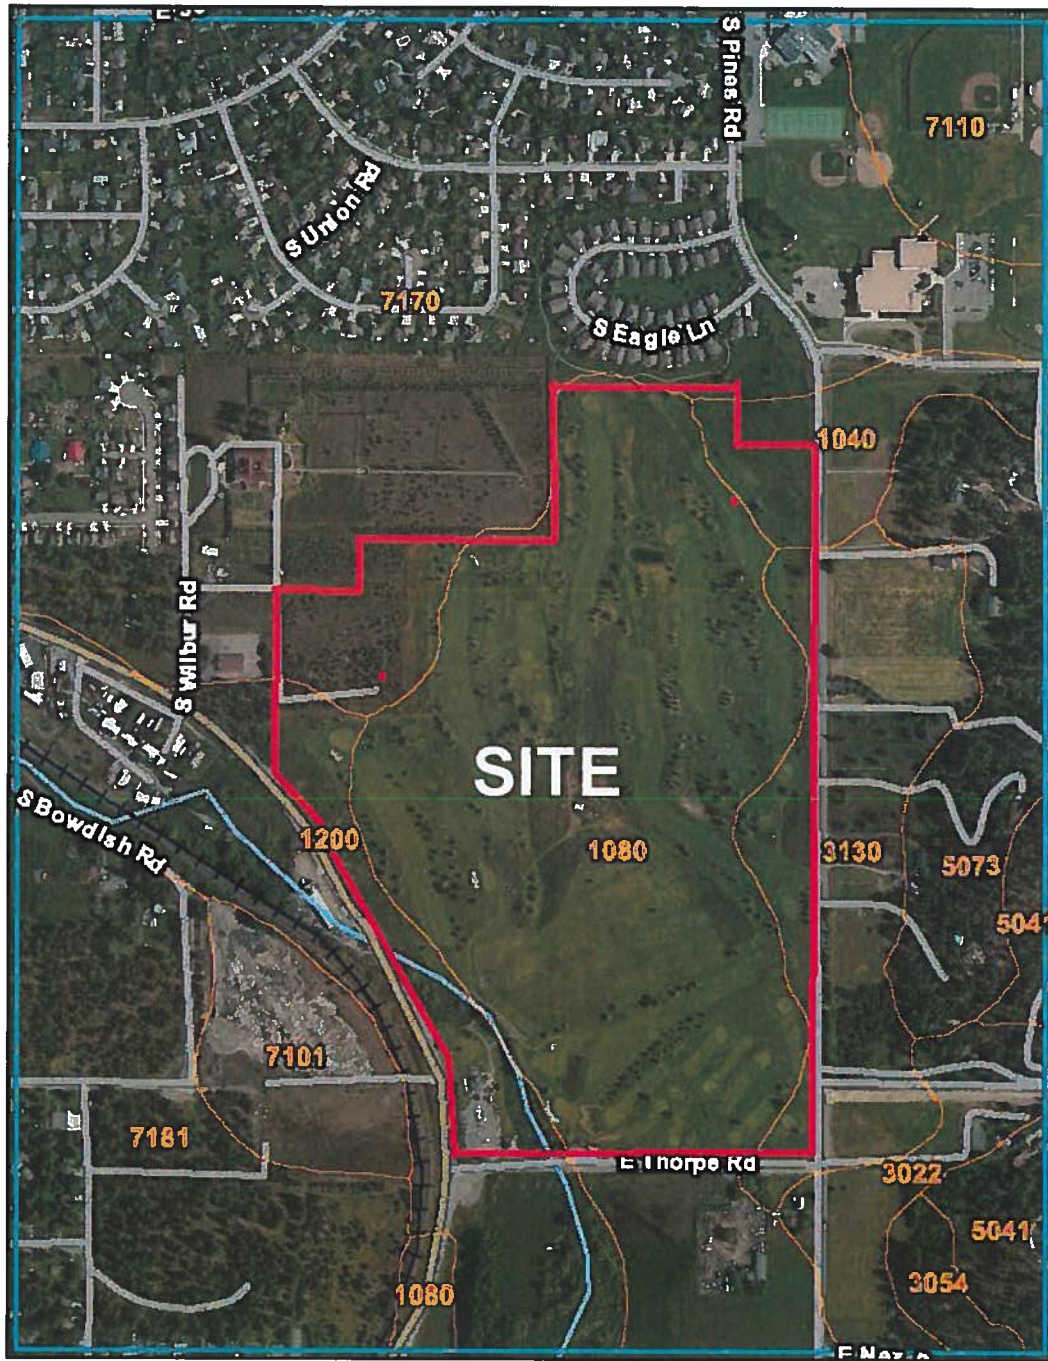
<b>NRCS Map</b>

Geologic maps indicate the soils in this area consist primarily of alluvial and/or glacially deposited silts, clays, sands, and gravels. According to the Soil Survey of Spokane County, the site soils are classified by the Natural Resource Conservation Service (NRCS) as Hardesty ash silt loam, Narcisse silt loam, Endoquolls and Fluvaquents, Phoebe ash sandy loam, and Urban land-Springdale disturbed complex. The native soils encountered in the test pits were consistent with the NRCS data.

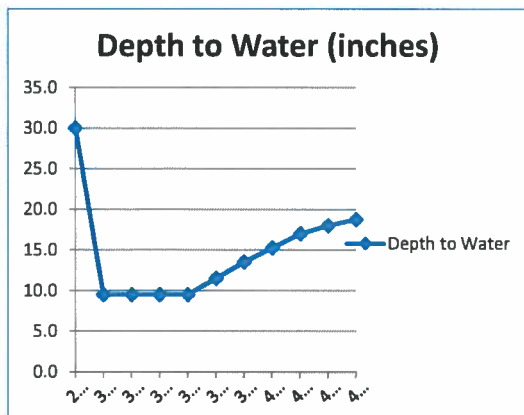
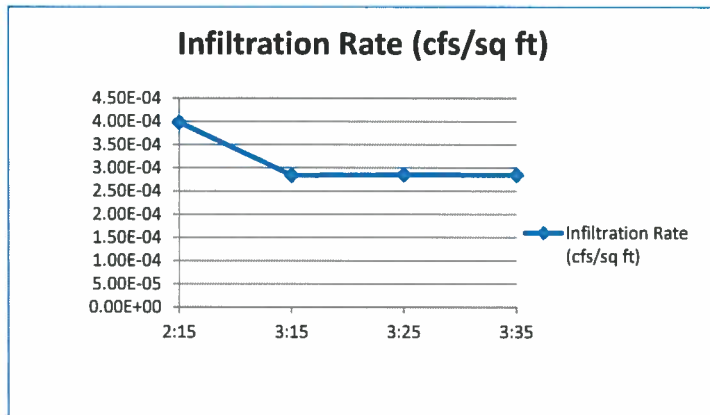
Time	Elapsed Time (seconds)	Depth to Water (inches)	Flow Meter Reading (ft <sup>3</sup> )	Volume of Water (ft <sup>3</sup> )	Flow Rate (cfs)	Infiltration Rate (cfs/ft <sup>2</sup> )
2:15	0	30.0	453.21			
3:15	3600	9.5	518.01	64.80	1.80E-02	3.98E-04
3:25	600	9.5	525.71	7.70	1.28E-02	2.84E-04
3:35	600	9.5	533.44	7.73	1.29E-02	2.85E-04
3:45	600	9.5	541.15	7.71	1.28E-02	2.84E-04
3:50	300	11.5				
3:55	300	13.5				
4:00	300	15.3				
4:05	300	17.0				
4:10	300	18.0				
4:15	300	18.8

Average Infiltration Rate: 2.84E-04

Test Location	Depth (feet)	USCS Classification	Percent Fines	Infiltration Rate (cfs/ft <sup>2</sup> )
P-1 (TP-3)	1 – 3	SW-SM	10.8	2.84 x 10 <sup>-4</sup>
P-2 (TP-8)	1.5 – 3.5	SM	12.5	8.36 x 10 <sup>-4</sup>
P-3 (TP-19)	1 – 3	GW	3.0	1.21 x 10 <sup>-3</sup>
P-4 (TP-22)	2 – 4	ML	64.0	1.29 x 10 <sup>-4</sup>
P-5 (TP-28)	2 – 4	SM	47.0	6.93 x 10 <sup>-5</sup>

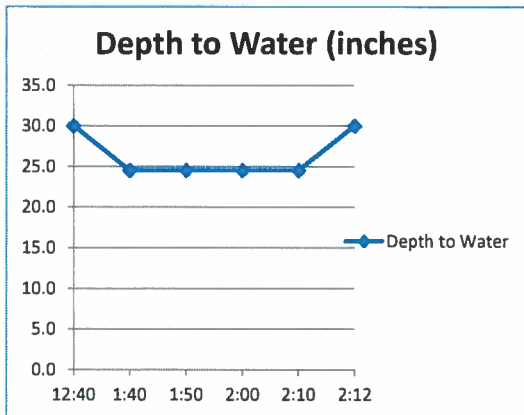
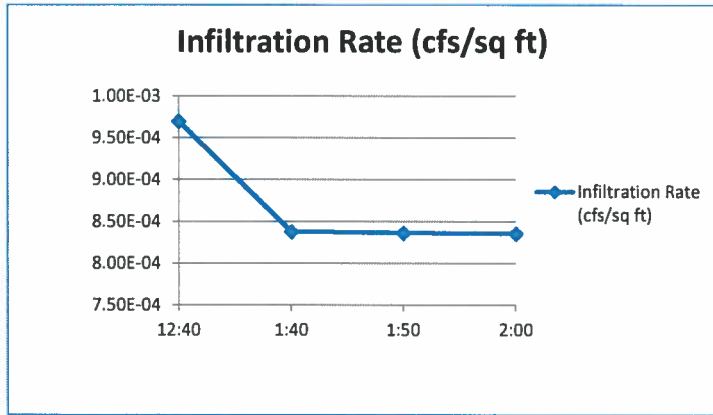
Time	Elapsed Time (seconds)	Depth to Water (inches)	Flow Meter Reading (ft <sup>3</sup> )	Volume of Water (ft <sup>3</sup> )	Flow Rate (cfs)	Infiltration Rate (cfs/ft <sup>2</sup> )
12:40	0	30.0	339.46			
1:40	3600	24.5	418.94	79.48	2.21E-02	9.70E-04
1:50	600	24.5	430.38	11.44	1.91E-02	8.37E-04
2:00	600	24.5	441.80	11.42	1.90E-02	8.36E-04
2:10	600	24.5	453.21	11.41	1.90E-02	8.35E-04
2:12	120	30.0

Average Infiltration Rate: 8.36E-04

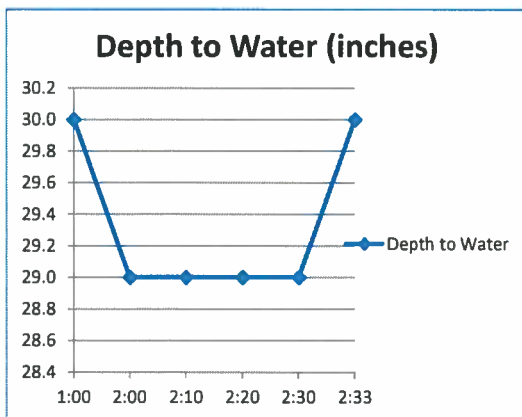
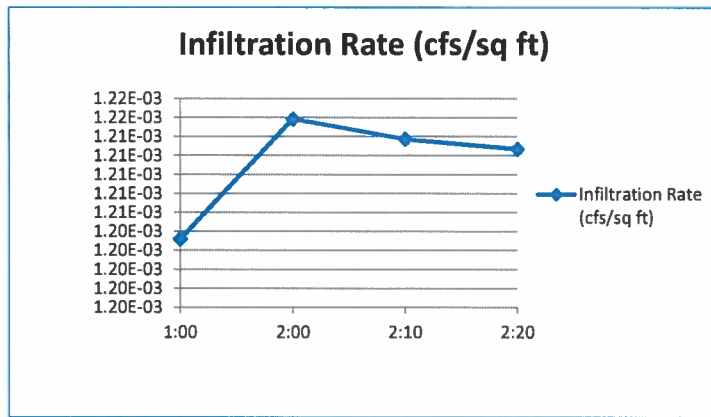
Time	Elapsed Time (seconds)	Depth to Water (inches)	Flow Meter Reading (ft <sup>3</sup> )	Volume of Water (ft <sup>3</sup> )	Flow Rate (cfs)	Infiltration Rate (cfs/ft <sup>2</sup> )
1:00	0	30.0	246.55			
2:00	3600	29.0	314.95	68.40	1.90E-02	1.20E-03
2:10	600	29.0	326.47	11.52	1.92E-02	1.22E-03
2:20	600	29.0	337.97	11.50	1.92E-02	1.21E-03
2:30	600	29.0	349.46	11.49	1.91E-02	1.21E-03
2:33	180	30.0

Average Infiltration Rate: 1.21E-03

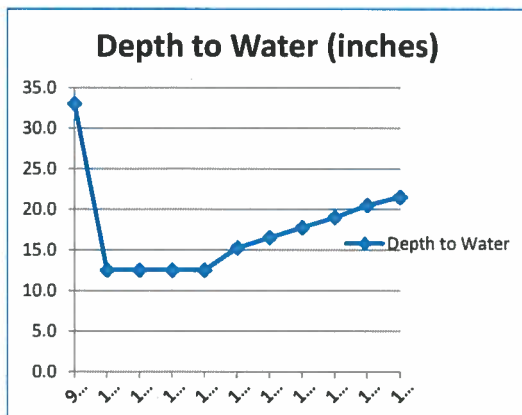
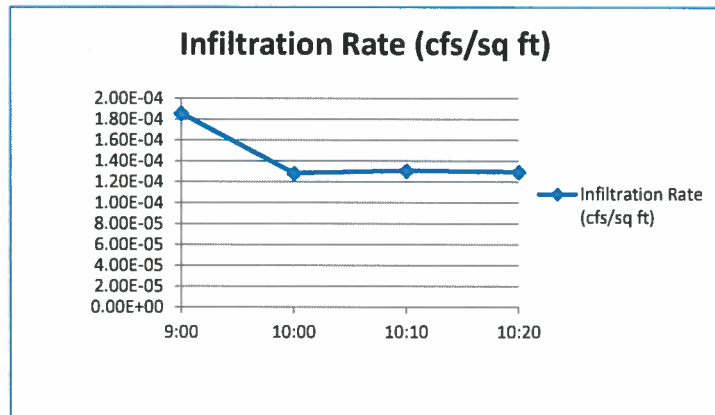
Time	Elapsed Time (seconds)	Depth to Water (inches)	Flow Meter Reading (ft <sup>3</sup> )	Volume of Water (ft <sup>3</sup> )	Flow Rate (cfs)	Infiltration Rate (cfs/ft <sup>2</sup> )
9:00	0	33.0	208.24			
10:00	3600	12.5	236.65	28.41	7.89E-03	1.85E-04
10:10	600	12.5	239.92	3.27	5.45E-03	1.28E-04
10:20	600	12.5	243.25	3.33	5.55E-03	1.30E-04
10:30	600	12.5	246.55	3.30	5.50E-03	1.29E-04
10:35	300	15.3				
10:40	300	16.5				
10:45	300	17.8				
10:50	300	19.0				
10:55	300	20.5				
11:00	300	21.5

Average Infiltration Rate: 1.29E-04

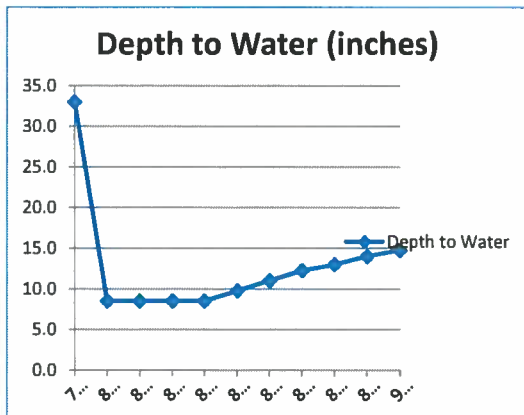
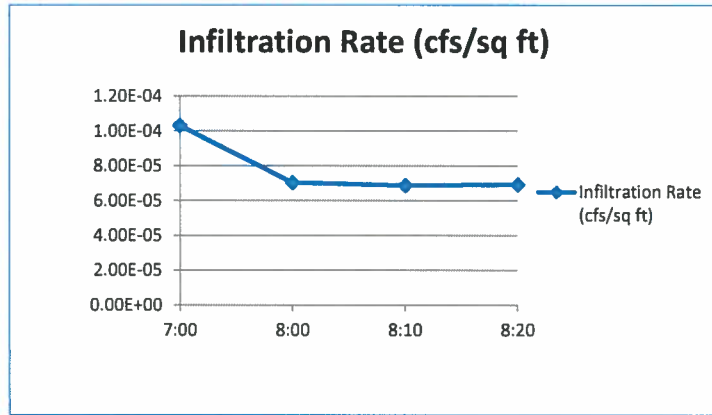
Time	Elapsed Time (seconds)	Depth to Water (inches)	Flow Meter Reading (ft <sup>3</sup> )	Volume of Water (ft <sup>3</sup> )	Flow Rate (cfs)	Infiltration Rate (cfs/ft <sup>2</sup> )
7:00	0	33.0	178.46			
8:00	3600	8.5	200.75	22.29	6.19E-03	1.03E-04
8:10	600	8.5	203.28	2.53	4.22E-03	7.02E-05
8:20	600	8.5	205.75	2.47	4.12E-03	6.86E-05
8:30	600	8.5	208.24	2.49	4.15E-03	6.91E-05
8:35	300	9.8				
8:40	300	11.0				
8:45	300	12.3				
8:50	300	13.0				
8:55	300	14.0				
9:00	300	14.8

Average Infiltration Rate: 6.93E-05

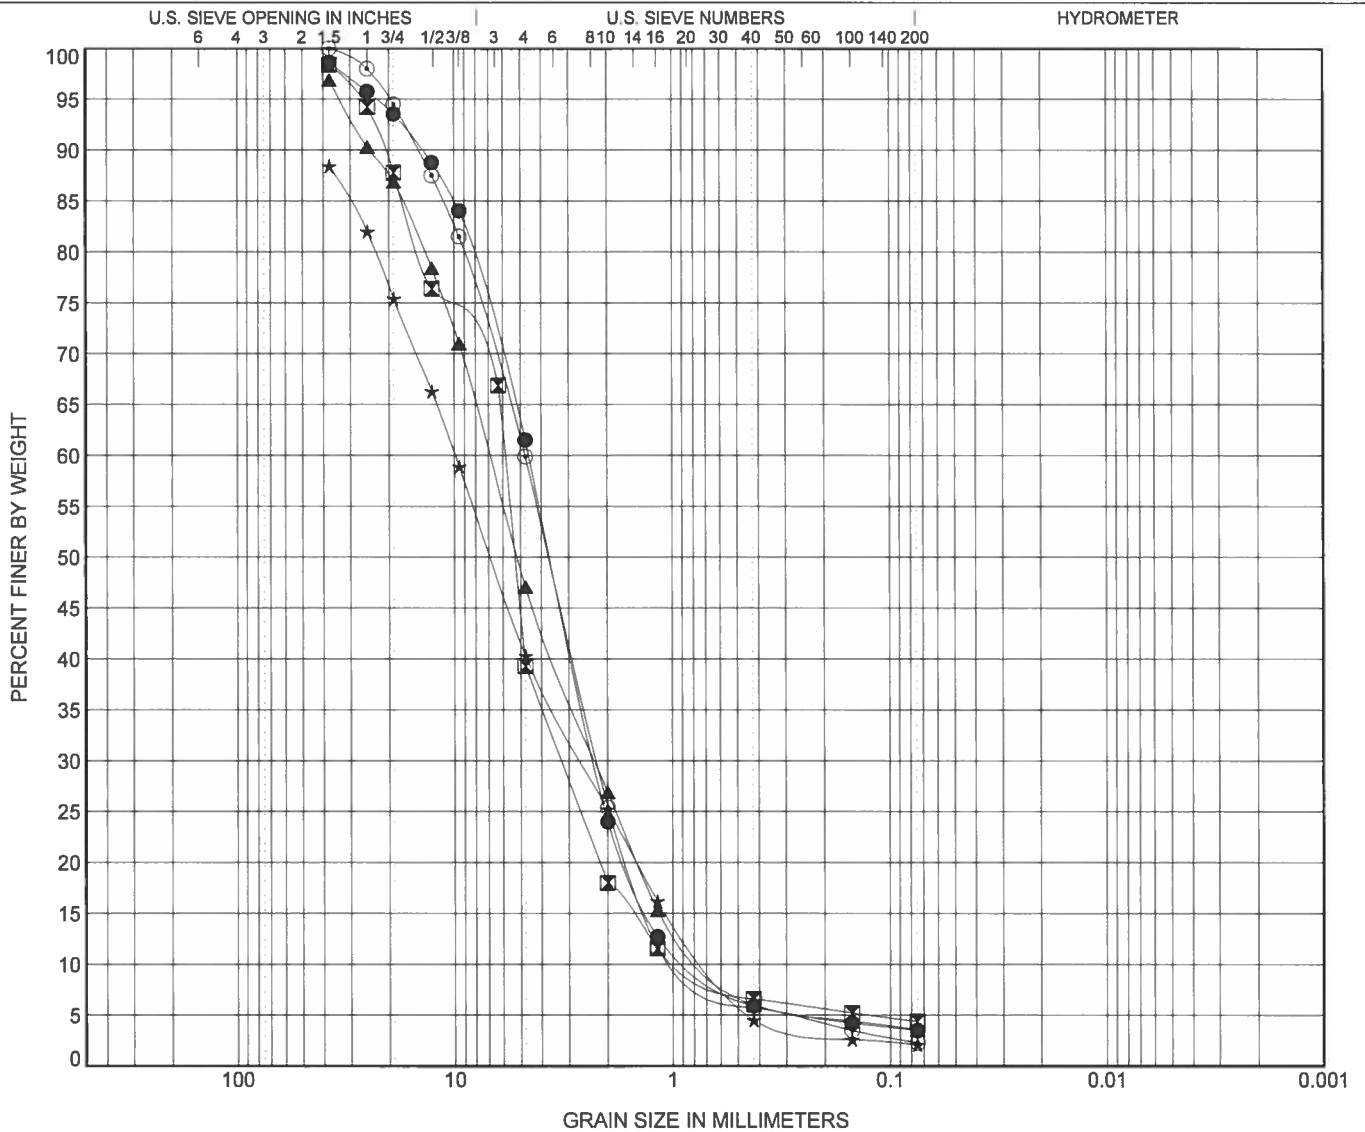
COBBLES	GRAVEL		SAND			SILT OR CLAY
	coarse	fine	coarse	medium	fine

BOREHOLE	DEPTH	Classification					LL	PL	PI	Cc	Cu
● TP-3	10'-12'	POORLY GRADED SAND with GRAVEL(SP)								1.46	5.83
☒ TP-4	12'	WELL-GRADED GRAVEL with SAND(GW)								2.10	6.83
▲ TP-8	10'-12'	WELL-GRADED GRAVEL with SAND(GW)								1.15	10.47
★ TP-9	8'-10'	WELL-GRADED GRAVEL with SAND(GW)								1.02	14.44
⊙ TP-11	10'-12'	POORLY GRADED SAND with GRAVEL(SP)								1.18	5.33
BOREHOLE	DEPTH	D100	D60	D30	D10	%Gravel	%Sand	%Silt	%Clay		
● TP-3	10'-12'	37.5	4.586	2.296	0.787	37.1	58.0	3.5			
☒ TP-4	12'	37.5	5.871	3.256	0.86	59.1	34.9	4.4			
▲ TP-8	10'-12'	37.5	6.905	2.284	0.659	49.8	43.5	3.6			
★ TP-9	8'-10'	37.5	9.919	2.633	0.687	48.1	38.2	2.1			
⊙ TP-11	10'-12'	37.5	4.765	2.244	0.895	40.1	57.6	2.3

Test Pit	Depth (feet)	USCS Classification	Percent Fines	Hydraulic Conductivity (cm/s)	Recommended Drywell Outflow Rate (cfs)	
					Type A	Type B
TP-3	10 – 12	SP	3.5	$6.1 \times 10^{-2}$	0.3	1.0
TP-4	10 – 12	GW	4.4	$4.1 \times 10^{-2}$	0.3	0.8
TP-8	10 – 12	GW	3.6	$5.9 \times 10^{-2}$	0.3	1.0
TP-9	8 – 10	GW	2.1	$1.7 \times 10^{-1}$	0.3	1.0
TP-11	10 – 12	SP	2.3	$1.5 \times 10^{-1}$	0.3	1.0
TP-13	10 – 12	SP	2.2	$1.6 \times 10^{-1}$	0.3	1.0
TP-17	10 – 12	SW	2.9	$9.0 \times 10^{-2}$	0.3	1.0
TP-19	10 – 12	SP	1.6	$2.5 \times 10^{-1}$	0.3	1.0
TP-29	10 – 12	SP	2.3	$1.5 \times 10^{-1}$	0.3	1.0
TP-30	14 – 15	SP	4.3	$4.3 \times 10^{-2}$	0.3	0.8

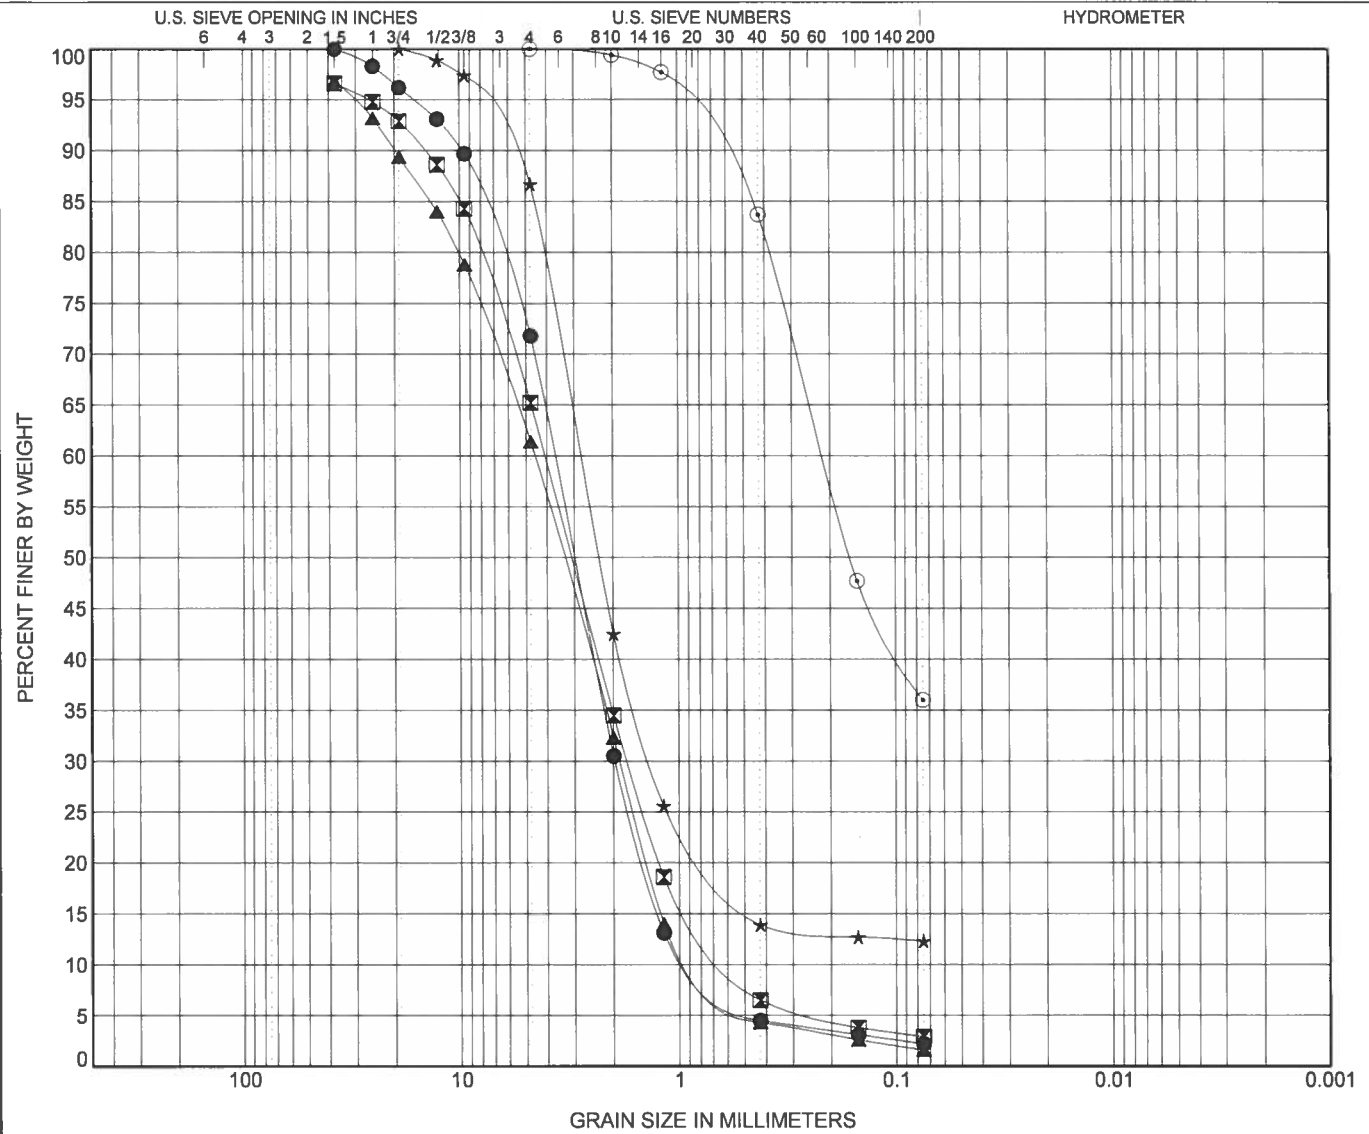
COBBLES	GRAVEL		SAND			SILT OR CLAY
	coarse	fine	coarse	medium	fine

BOREHOLE	DEPTH	Classification					LL	PL	PI	Cc	Cu
● TP-13	10'-12'	POORLY GRADED SAND with GRAVEL(SP)								1.28	4.54
⊠ TP-17	10'-12'	WELL-GRADED SAND with GRAVEL(SW)								1.27	7.18
▲ TP-19	10'-12'	POORLY GRADED SAND with GRAVEL(SP)								0.99	5.88
★ TP-22	10'-12'	SILTY SAND(SM)									
○ TP-27	9'-10'	SILTY SAND(SM)									
BOREHOLE	DEPTH	D100	D60	D30	D10	%Gravel	%Sand	%Silt	%Clay		
● TP-13	10'-12'	37.5	3.71	1.97	0.817	28.2	69.6		2.2		
⊠ TP-17	10'-12'	37.5	4.103	1.723	0.571	31.4	62.3		2.9		
▲ TP-19	10'-12'	37.5	4.556	1.872	0.774	35.4	59.8		1.6		
★ TP-22	10'-12'	19	2.817	1.354		13.3	74.4		12.3		
○ TP-27	9'-10'	4.75	0.214			0.0	64.0		36.0

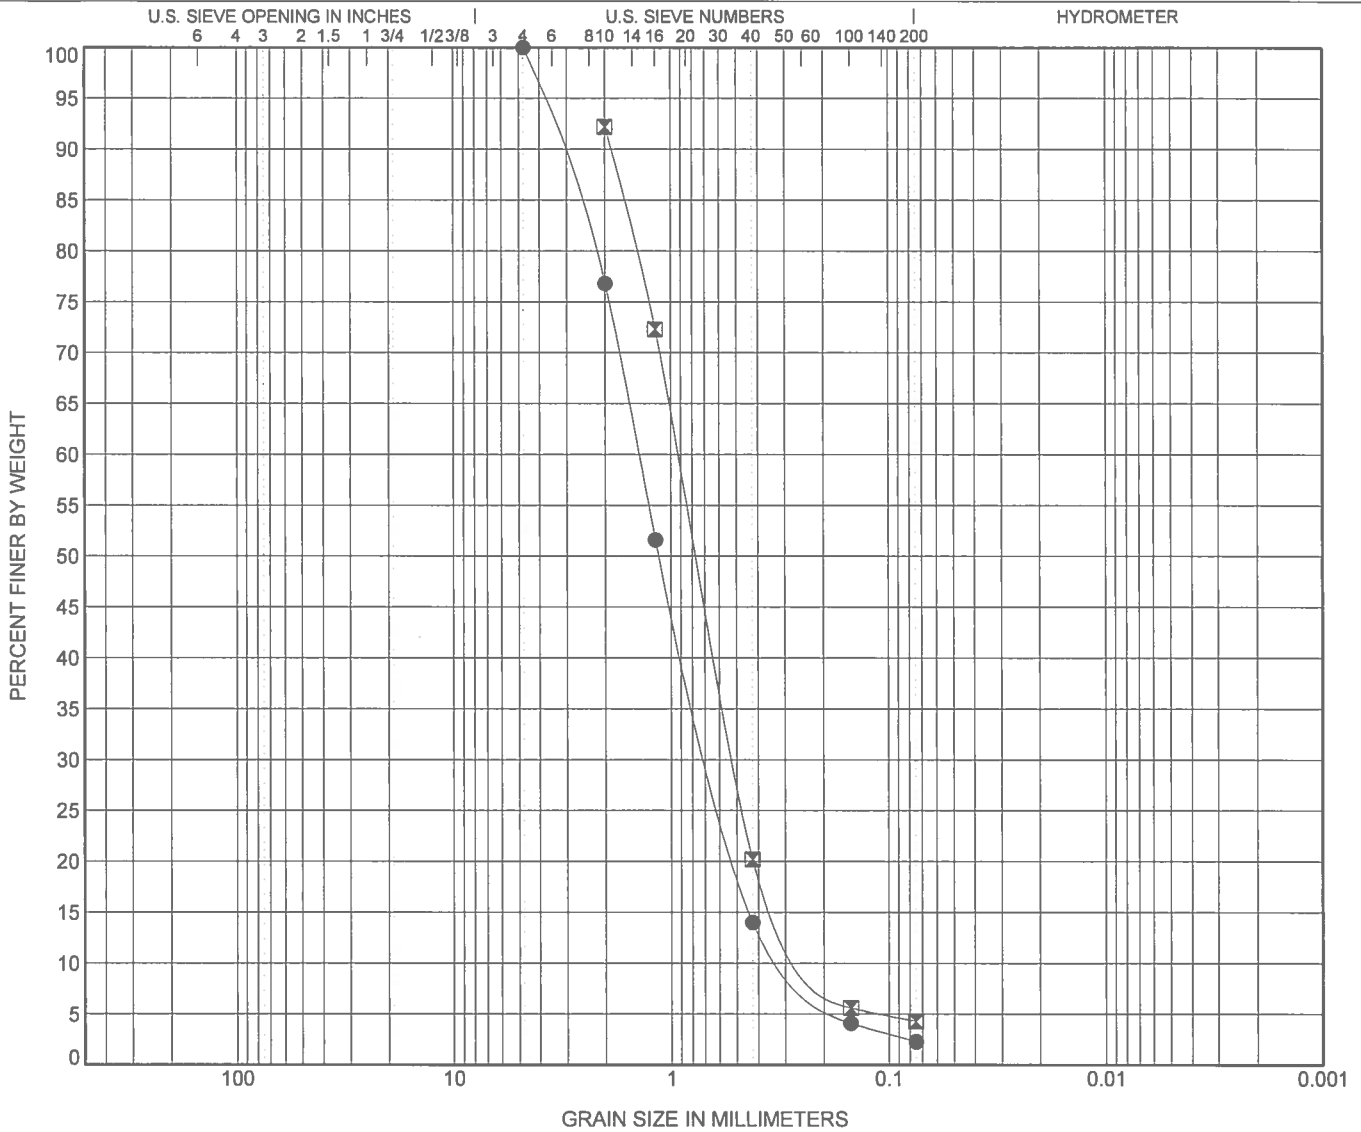
COBBLES	GRAVEL		SAND			SILT OR CLAY
	coarse	fine	coarse	medium	fine

BOREHOLE	DEPTH	Classification					LL	PL	PI	Cc	Cu
● TP-29	10'-12'	POORLY GRADED SAND(SP)								1.10	5.04
× TP-30	14'-15'	POORLY GRADED SAND(SP)								1.39	4.52
BOREHOLE	DEPTH	D100	D60	D30	D10	%Gravel	%Sand	%Silt	%Clay		
● TP-29	10'-12'	4.75	1.407	0.656	0.279	0.0	97.7		2.3		
× TP-30	14'-15'	2	0.927	0.515	0.205		87.9		4.3

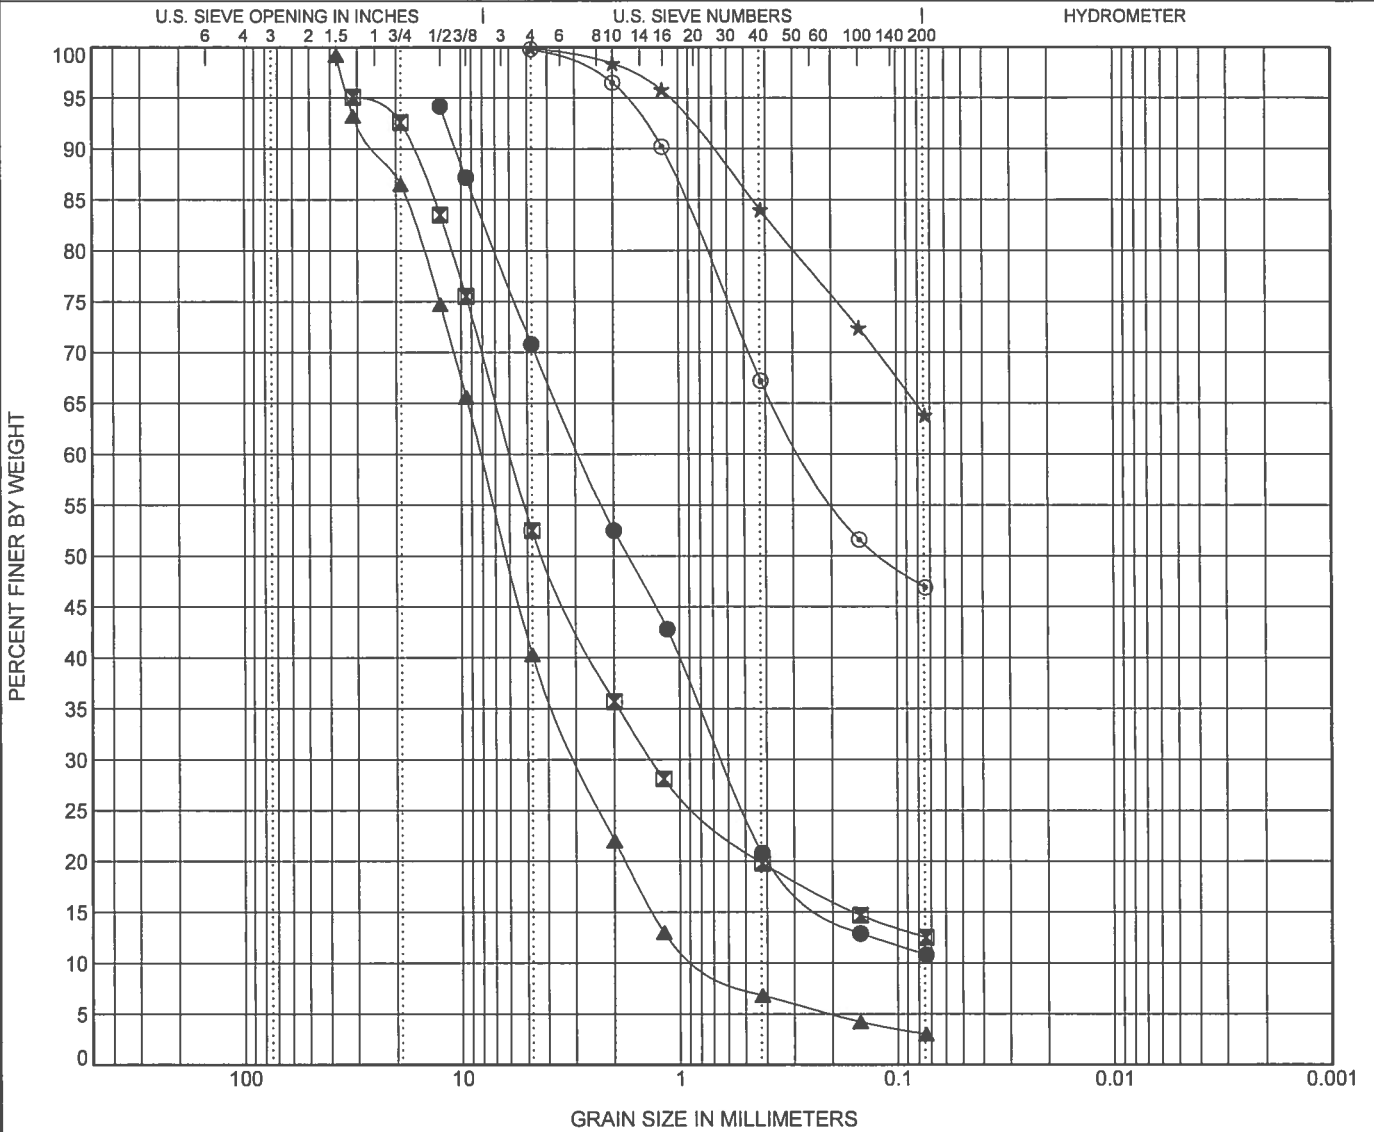
COBBLES	GRAVEL		SAND			SILT OR CLAY
	coarse	fine	coarse	medium	fine

Specimen Identification	Classification	LL	PL	PI	Cc	Cu		
● TP-3	2.0 WELL-GRADED SAND with SILT and GRAVEL (SW-SM)				2.51	50.34		
☒ TP-8	2.0 SILTY SAND (SM) with GRAVEL							
▲ TP-19	2.0 WELL-GRADED GRAVEL with SAND (GW)				1.46	11.34		
★ TP-22	3.0 SANDY SILT (ML)							
◎ TP-28	3.0 SILTY SAND (SM)							
Specimen Identification	D100	D60	D30	D10	%Gravel	%Sand	%Silt	%Clay
● TP-3	2.0	12.5	2.853	0.638	23.4	59.9	10.8	
☒ TP-8	2.0	31.25	5.963	1.355	42.6	39.9	12.5	
▲ TP-19	2.0	37.5	8.153	2.922	0.719	58.9	37.2	3.0
★ TP-22	3.0	4.76			0.0	35.9	64.0	
◎ TP-28	3.0	4.76	0.26		0.0	52.8	47.0
