BIOLOGICAL EVALUATION, BUFFER AVERAGING, AND HABITAT MANAGEMENT PLAN Spokane County Tax Parcels #45336.9191 and 44041.9144 July 20, 2015

Biology
Soil &
Water, Inc.

#### BIOLOGICAL EVALUATION, BUFFER AVERAGING, AND HABITAT MANAGEMENT PLAN

#### PAINTED HILLS PRD

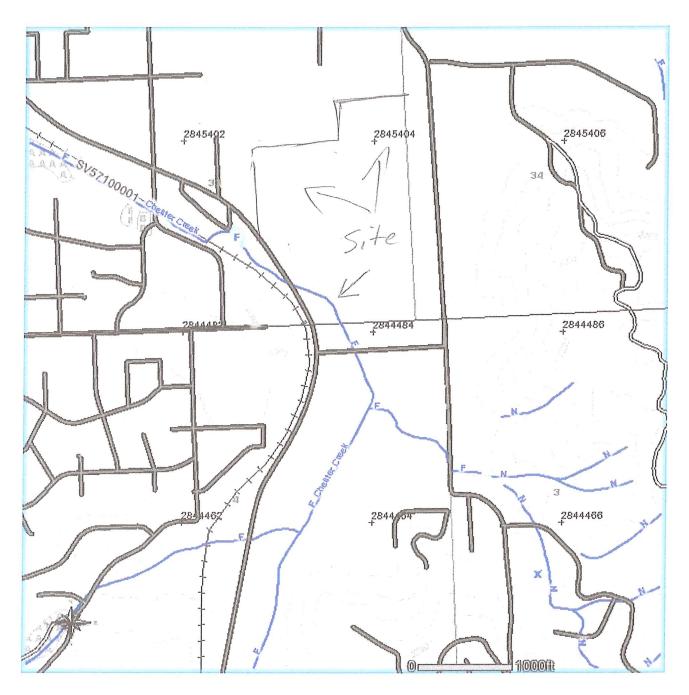
The DNR Water Type Map (Figure 5) defines Chester Creek as a Type F Water. Chapter 21.40 of the City of Spokane Valley Municipal Code, titled Critical Areas, bases stream buffer widths on the DNR Riparian Management Zones. Chester Creek is greater than 15 feet in width (bankfull) so the appropriate buffer width can be found in Table 21.40-10 of the City Code. The DNR guidance states that in Eastern Washington, if there is no site index information, as in this case, assume Site Class III unless site specific information indicates otherwise. The table indicates that a Type F Natural Water not classified as a Shoreline of the State, having a Site Class 3 designation, has a total buffer width of 100 feet. BSW delineated the Chester Creek OHWM in the field on March 31, 2015. The OHWM flags were surveyed and plotted on the site plan map along with the 100-foot riparian buffer by Whipple Consulting Engineers.
