WCE No. 2013-1166

Whipple Consulting Engineers, Inc.

Revised
March 6, 2019

Re: Painted Hills Flood Control Development Narrative

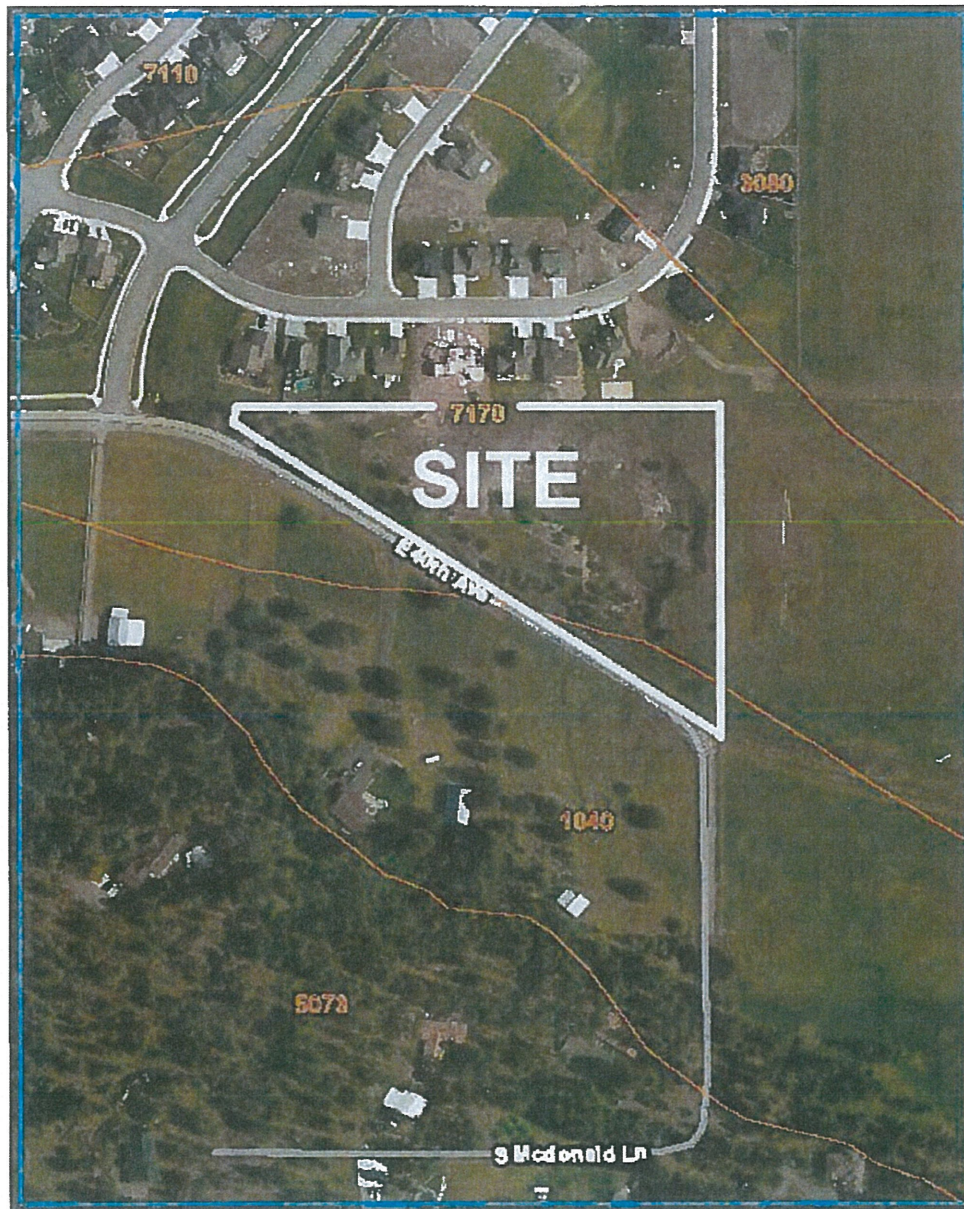
FIGURE 2

NRCS Map		
IPEC Inland Pacific Engineering Company Geotechnical Engineering and Consulting	Project No. 14-086	October 9, 2014
	Proposed Stormwater Pond Parcel No. 45343.9052 Spokane County, WA

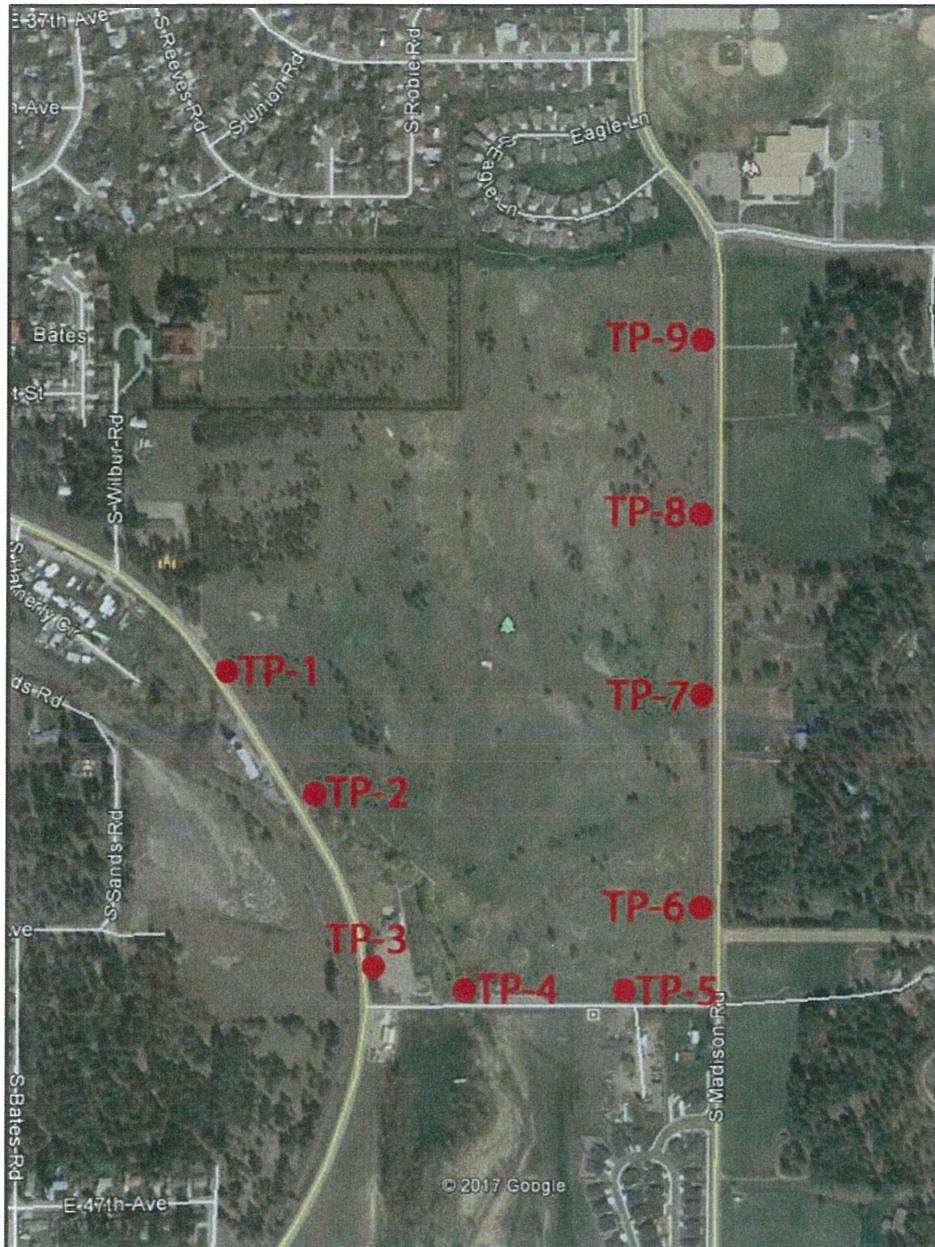
FIGURE 3

Test Pit Location Map 1

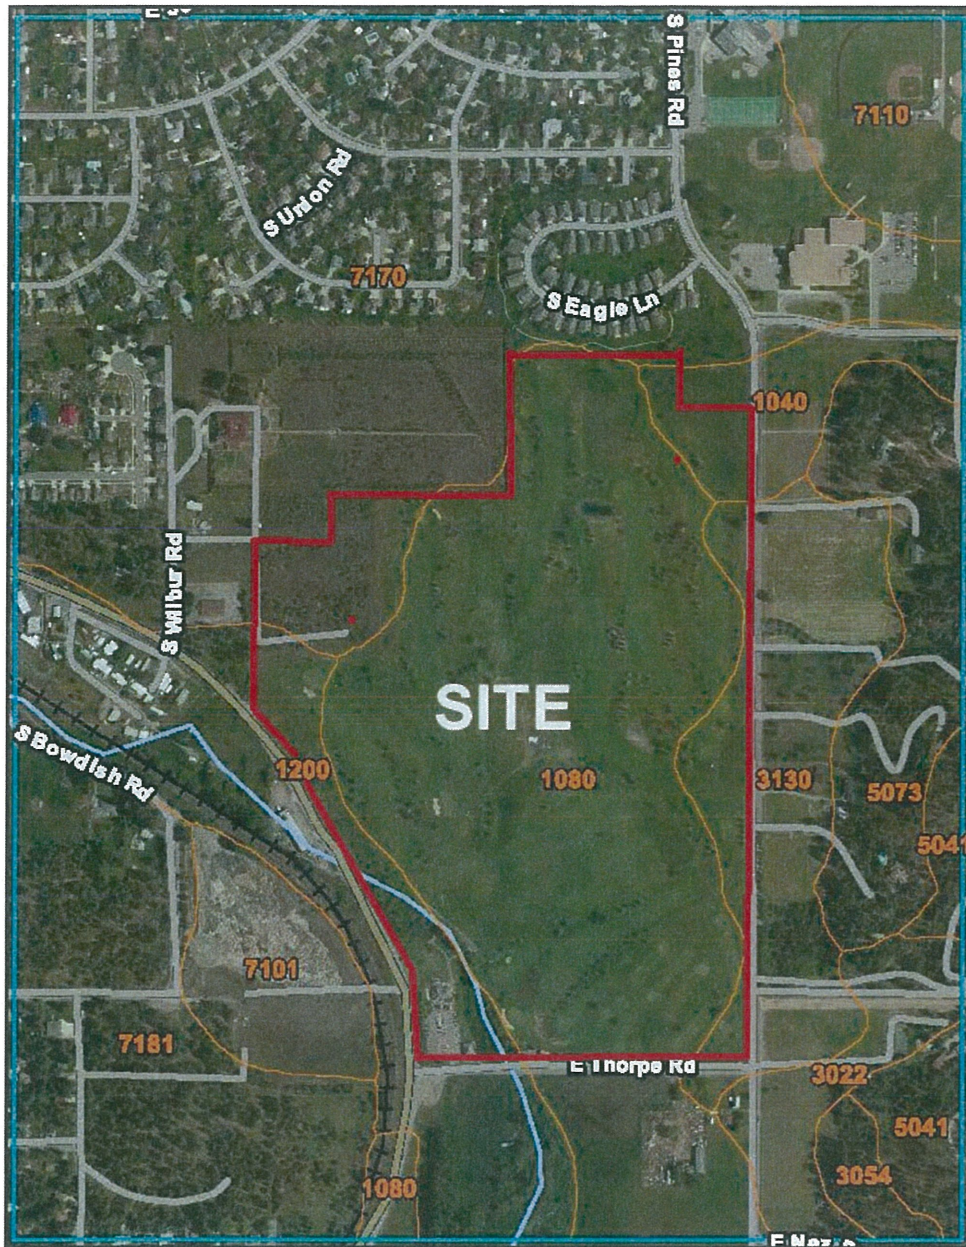
FIGURE 2

NRCS Map		
IPEC Inland Pacific Engineering Company Geotechnical Engineering and Consulting	Project No. 16-249A	June 28, 2016
	Painted Hills Golf Course 4403 South Dishman-Mica Road Spokane County, WA
