**GEOTECHNICAL EVALUATION
LEVEE EVALUATION AND CERTIFICATION
4403 SOUTH DISHMAN-MICA ROAD
SPOKANE COUNTY, WASHINGTON**

Inland Pacific Engineering Company Project No. 14-037

February 12, 2015

Re: **Geotechnical Evaluation**
Chester Creek Levee Certification
4403 South Dishman-Mica Road
Spokane County, WA

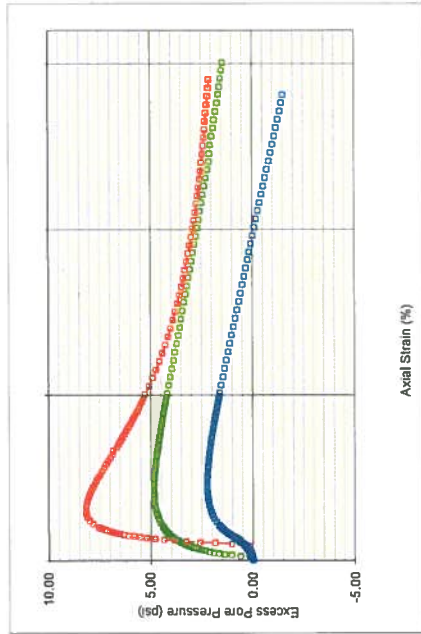
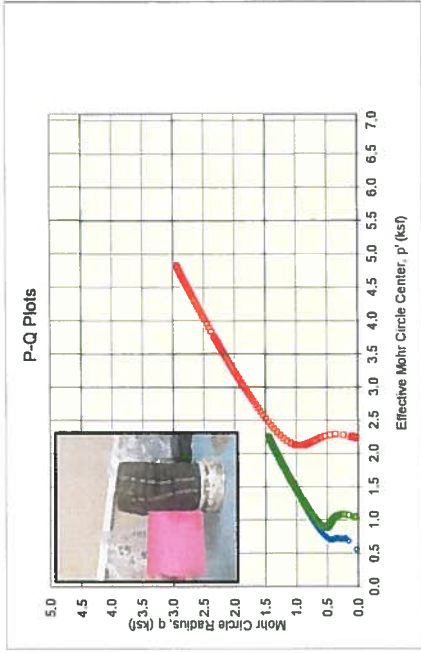
Report of CU Triaxial Shear Test

ASTM D4767-11

Laboratory Number: 14-0268		0.52 ksf		1.00 ksf		2.18 ksf	
Sample Number: B1 21-23		109.0		111.9		124.4	
Sample Description: Brown Clay		25.5%		23.2%		12.9%	
Sample Source: Shelby 2.8" Tube		110.1		114.8		127.5	
Shear rate 2.67%/hour		19.6%		17.6%		16.3%	
Initial dry unit weight (pcf)	111.9	Initial Wc (%)	23.2%	124.4	12.9%		
Final dry unit weight (pcf)	110.1	Final Wc (%)	19.6%	114.8	127.5	16.3%	
		Consolidation Stress (ksf)		Peak Failure Stress			
		0.52		p		q	
		1.00		2.25		1.47	
		2.18		4.82		2.85

Above values are effective stresses

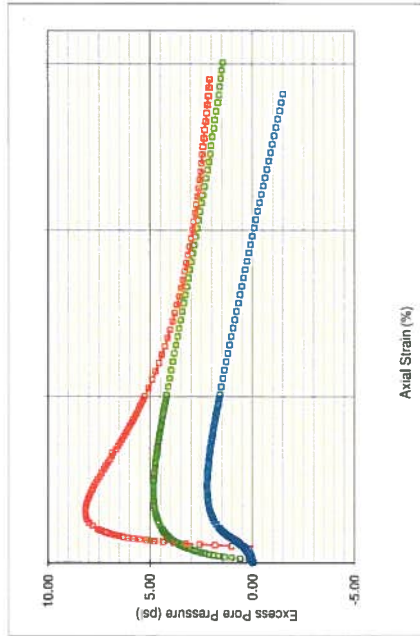
Report of CU Triaxial Shear Test

ASTM D4767-11

Laboratory Number: 14-0271
 Sample Number: B4 @ 16'-18"
 Sample Description: Brown Clay
 Sample Source: Shelby 2.8" Tube

Shear rate 2.87%/hour

Peak Failure Stress	
p (ksf)	q (ksf)
2.25	1.47
2.25	1.46
4.82	2.95

Above values are effective stresses

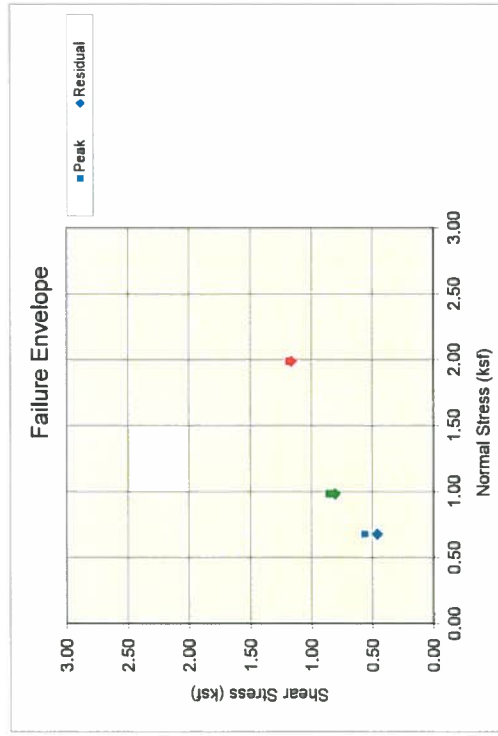
Report of Direct Shear Test

ASTM D3080

Laboratory Number: 14-0268
 Sample Number: B1 21-23 feet
 Sample Description: Brown Clay
 Sample Source: Shelby 2.8 inch tube

Shear rate .015 in./min.

0.5 ksf	1 ksf	2.0 ksf
Initial dry unit weight (pcf)	97.5	80.0	92.0
Initial Wc (%)	22.6%	35.2%	30.0%
Final Wc (%)	27.0%	32.7%	36.2%
Normal Stress (ksf)	0.68	0.98	1.98
Peak Shear Stress (ksf)	0.57	0.86	1.19
Residual Failure Stress (ksf)	0.47	0.81	1.17

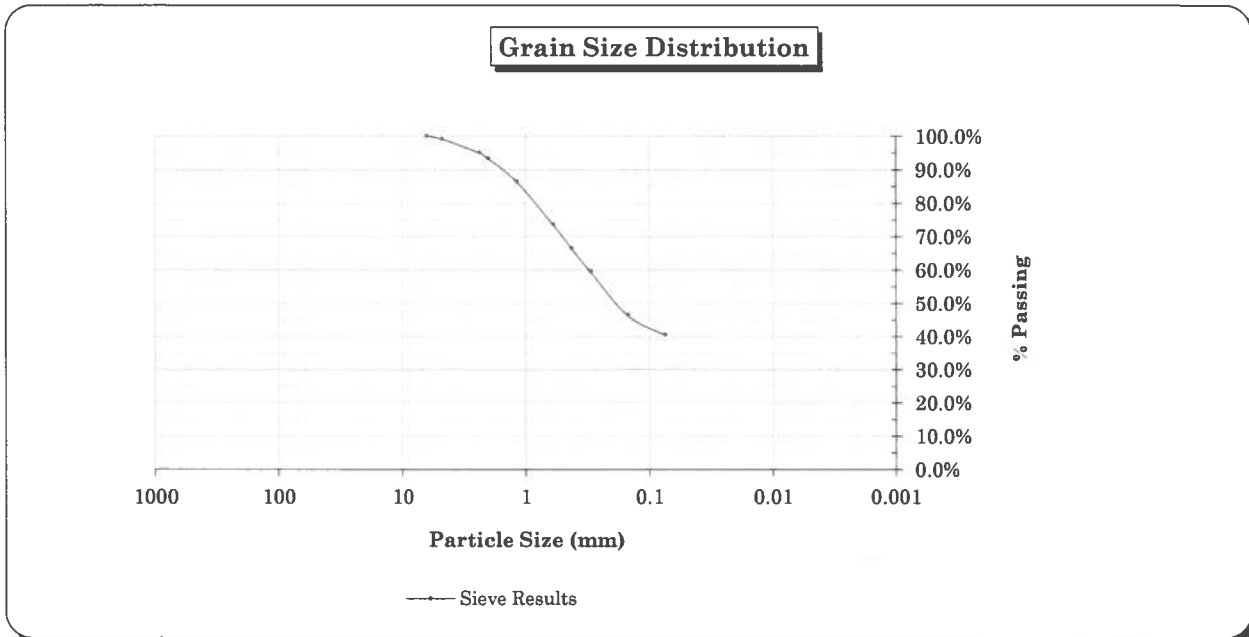
Fineness Modulus:
 % Gravel: 0.84
 % Sand: 58.80
 % Silt & Clay: 40.36
 Moisture Content: 14.2%

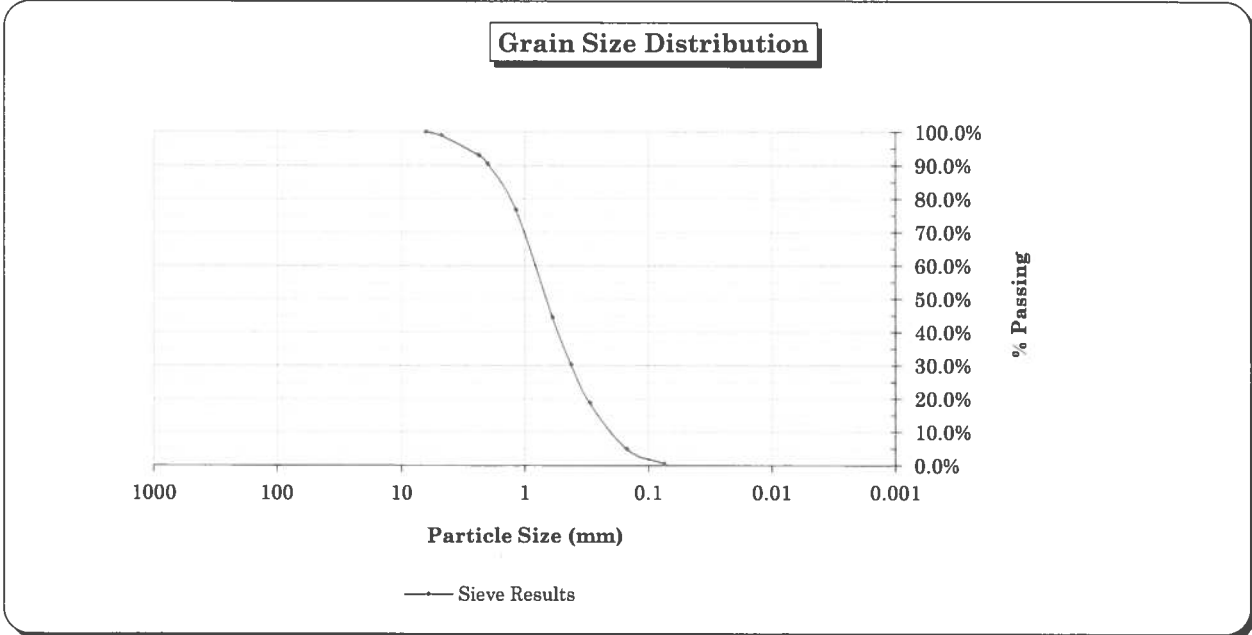
Fineness Modulus:
 % Gravel: 1.10
 % Sand: 98.30
 % Silt & Clay: 0.60
 Moisture Content:

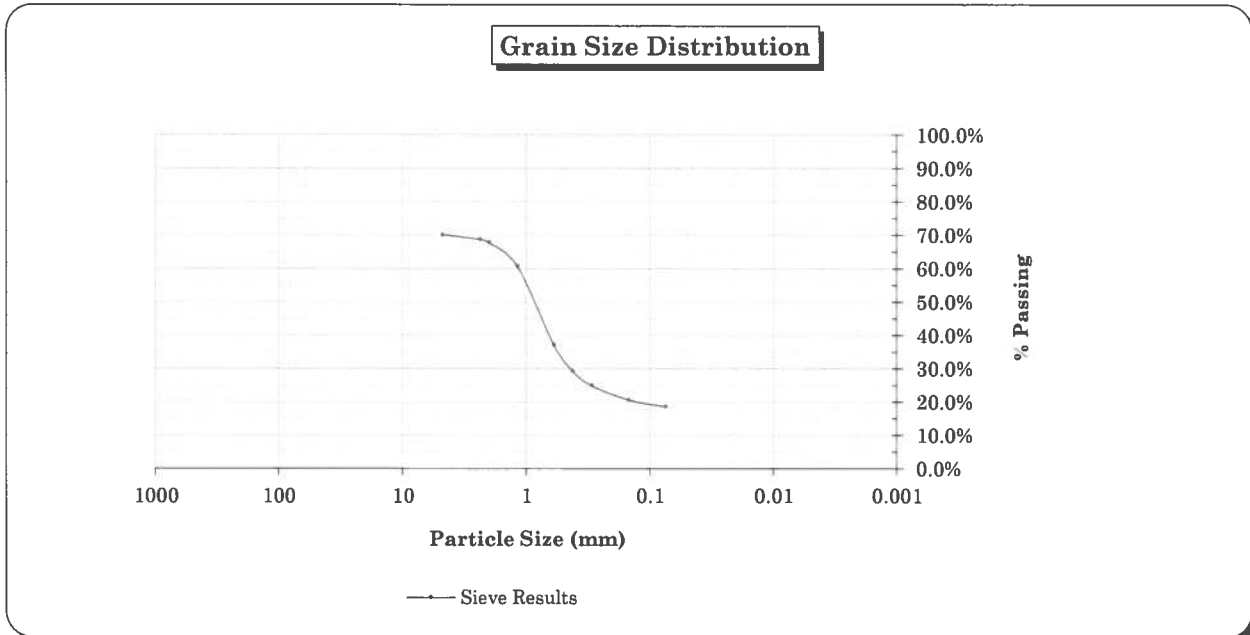
Fineness Modulus:
 % Gravel:
 % Sand: 51.56
 % Silt & Clay: 18.57
 Moisture Content: 12.1%
