PAINTED HILLS PRD
BIOLOGICAL EVALUATION, BUFFER AVERAGING,
AND HABITAT MANAGEMENT PLAN
Spokane County Tax Parcels #45336.9191 and 44041.9144
July 20, 2015 (Revised August 30, 2016)

BIOLOGICAL EVALUATION, BUFFER AVERAGING,
AND HABITAT MANAGEMENT PLAN

PAINTED HILLS PRD

Spokane County Tax Parcels #45336.9191 and 44041.9144
July 20, 2015 (Revised August 30, 2016)

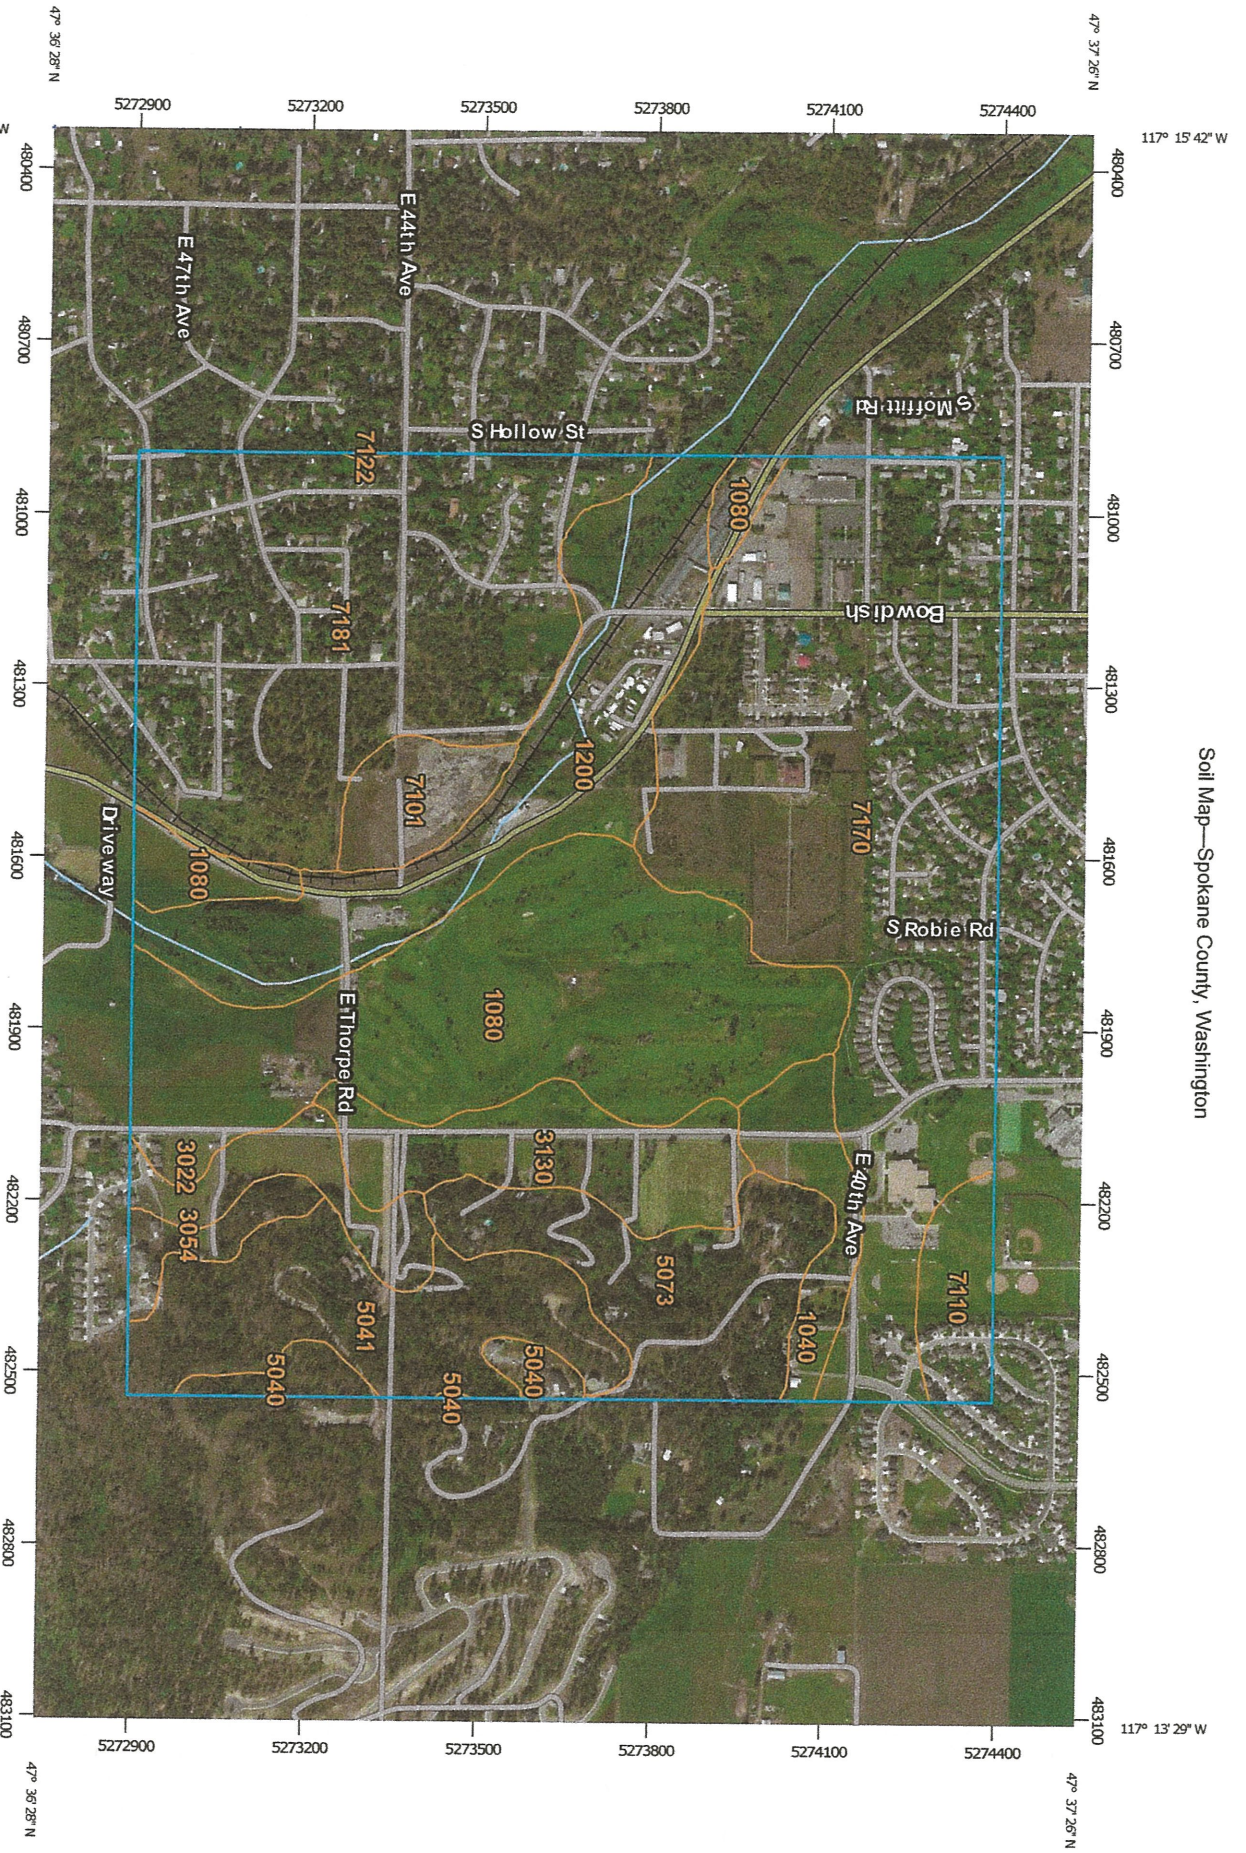
Soil Map—Spokane County, Washington

Spokane County, Washington (WA063)			
Map Unit Symbol	Map Unit Name	Acres in AOI	Percent of AOI
1040	Hardesty ashy silt loam, 0 to 3 percent slopes	14.4	2.3%
1080	Narcisse silt loam, 0 to 3 percent slopes	108.4	17.7%
1200	Endoaquolls and Fluvaquents, 0 to 3 percent slopes	61.9	10.1%
3022	Bong ashy sandy loam, moist, 0 to 8 percent slopes	14.3	2.3%
3054	Clayton ashy fine sandy loam, 0 to 8 percent slopes	7.2	1.2%
3130	Phoebe ashy sandy loam, 0 to 3 percent slopes	29.2	4.8%
5040	Spokane-Swakane complex, 3 to 15 percent slopes	7.9	1.3%
5041	Spokane-Swakane complex, 15 to 30 percent slopes	43.1	7.0%
5073	Lenz-Rock outcrop complex, 15 to 30 percent slopes	37.6	6.1%
7101	Pits-Dumps complex	12.0	2.0%
7110	Urban land-Opportunity, disturbed complex, 0 to 3 percent slopes	11.4	1.9%
7122	Urban land-Marble, disturbed complex, 8 to 15 percent slopes	0.1	0.0%
7170	Urban land-Springdale, disturbed complex, 0 to 3 percent slopes	153.0	24.9%
