**PAINTED HILLS PRD**  
**BIOLOGICAL EVALUATION, CRITICAL AREAS REPORT,**  
**AND HABITAT MANAGEMENT PLAN**  
Spokane County Tax Parcels #45336.9191 and 44041.9144  
February 28, 2019

BIOLOGICAL EVALUATION, CRITICAL AREAS REPORT,  
AND HABITAT MANAGEMENT PLAN

PAINTED HILLS PRD

Spokane County Tax Parcels #45336.9191 and 44041.9144  
February 28, 2019

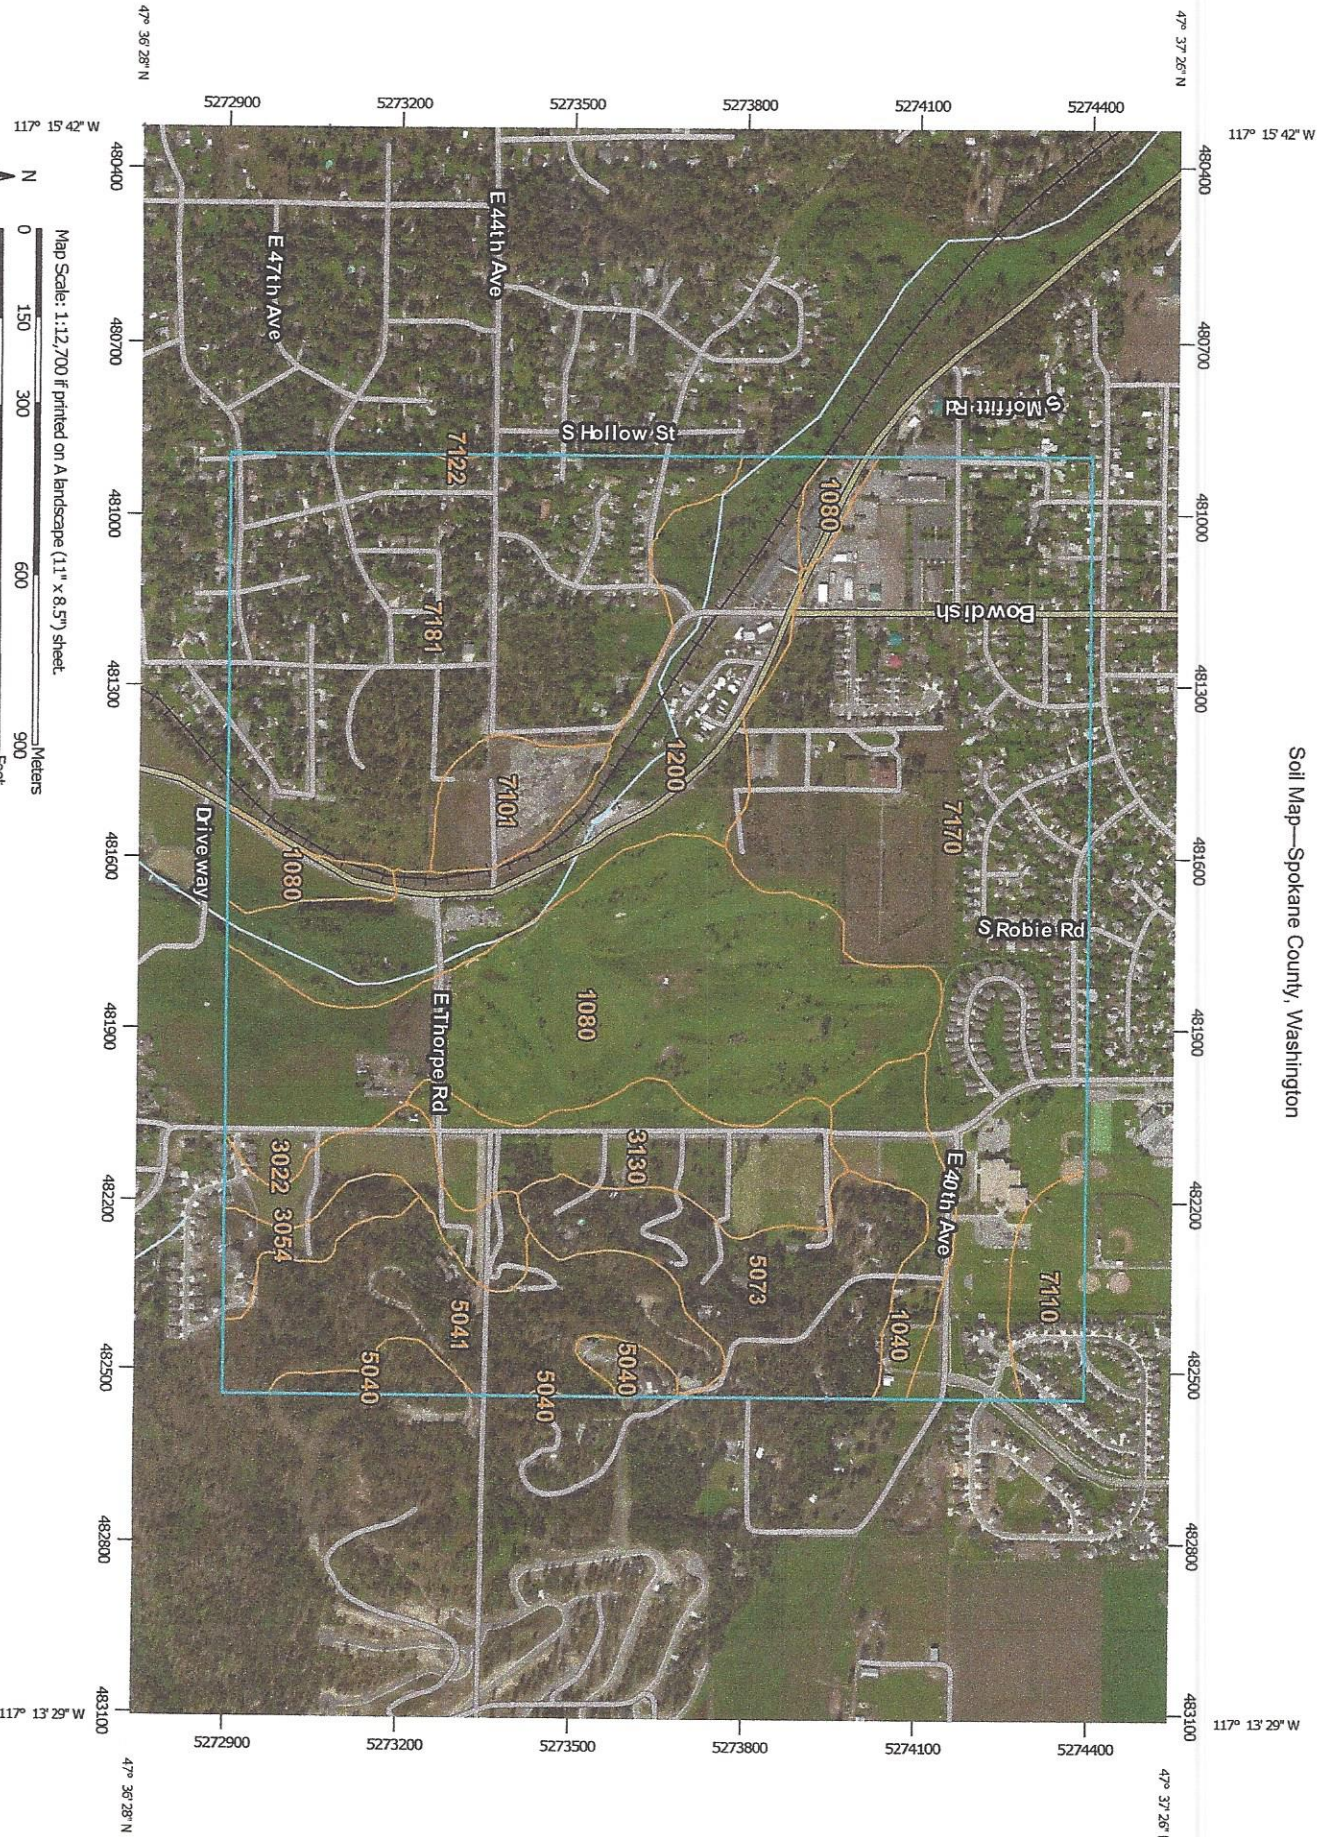
Soil Map—Spokane County, Washington

Map Scale: 1:12,700 if printed on A landscape (11" x 8.5") sheet.

Spokane County, Washington (WA063)			
Map Unit Symbol	Map Unit Name	Acres in AOI	Percent of AOI
1040	Hardesty ashy silt loam, 0 to 3 percent slopes	14.4	2.3%
1080	Narcisse silt loam, 0 to 3 percent slopes	108.4	17.7%
1200	Endoaquolls and Fluvaquents, 0 to 3 percent slopes	61.9	10.1%
3022	Bong ashy sandy loam, moist, 0 to 8 percent slopes	14.3	2.3%
3054	Clayton ashy fine sandy loam, 0 to 8 percent slopes	7.2	1.2%
3130	Phoebe ashy sandy loam, 0 to 3 percent slopes	29.2	4.8%
5040	Spokane-Swakane complex, 3 to 15 percent slopes	7.9	1.3%
5041	Spokane-Swakane complex, 15 to 30 percent slopes	43.1	7.0%
5073	Lenz-Rock outcrop complex, 15 to 30 percent slopes	37.6	6.1%
7101	Pits-Dumps complex	12.0	2.0%
7110	Urban land-Opportunity, disturbed complex, 0 to 3 percent slopes	11.4	1.9%
7122	Urban land-Marble, disturbed complex, 8 to 15 percent slopes	0.1	0.0%
7170	Urban land-Springdale, disturbed complex, 0 to 3 percent slopes	153.0	24.9%
